David T. Chuljian, DDS, PS

July 9, 2007

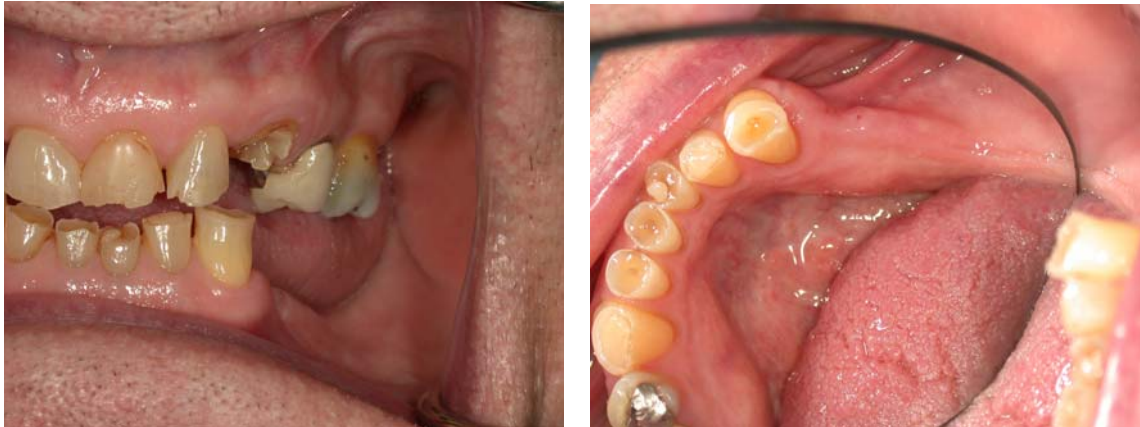
Above are preoperative photos of the left side; as you can see, there are no teeth on the lower left posterior (the photo on the right is taken with a mirror, so things are backwards). Although there are obviously problems with the front teeth, until some support is gained in back there's nothing we can do to fix the front.

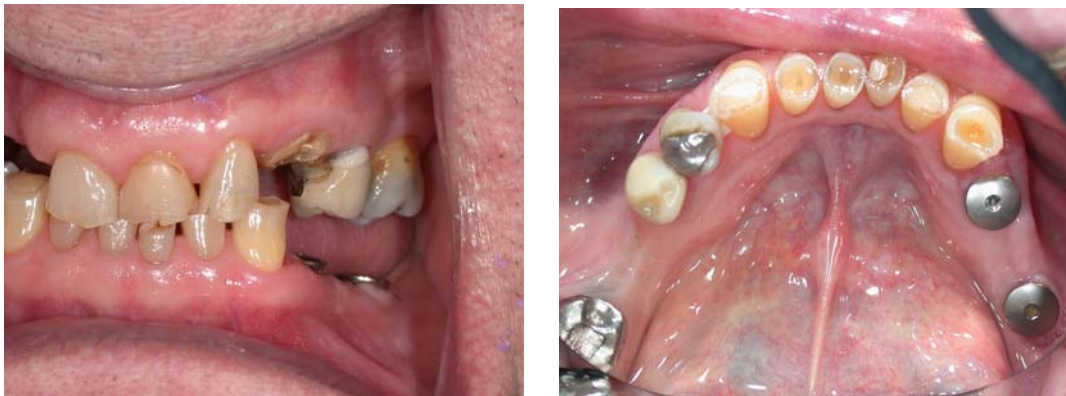
These photos show two implants placed on the lower left (again, the photo on the right is taken with a mirror). Notice they look pretty much like teeth broken off at the gumline. After the implants heal for a few months, machined posts were screwed into the implants, and a bridge was placed on the posts. Here's a photo of the finished bridge from the above implant case. Note that we've also done a bunch of work on the other teeth, but it is the same person:
