David T. Chuljian, DDS, PS

November 29, 2004

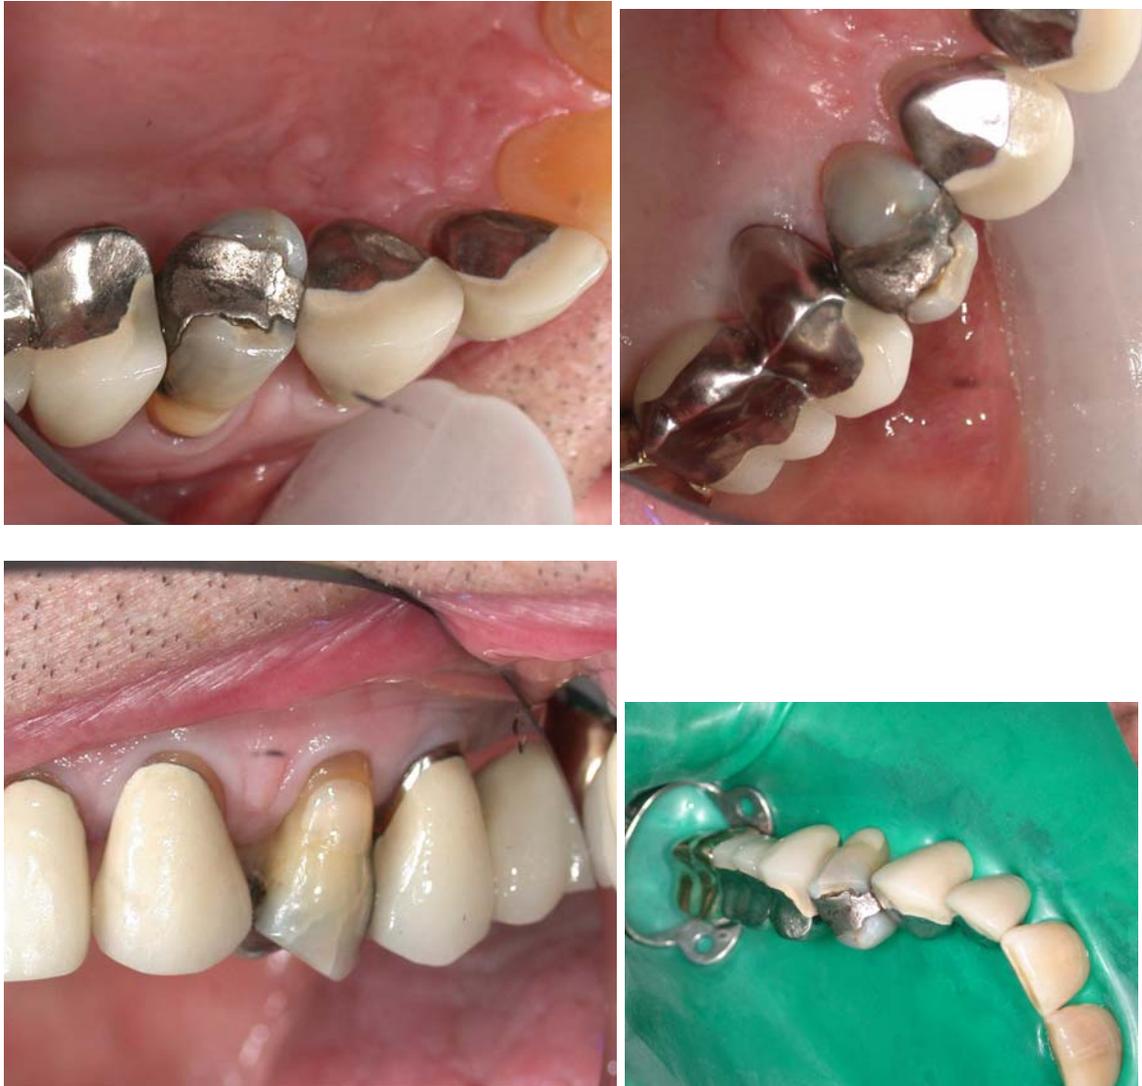
Pre-operative pictures of the tooth. Note cracks, and gray stains indicating corrosion of the amalgam (silver/mercury) filling. There was no obvious decay on this tooth, and the X-ray looked OK, but it clearly is wearing out.

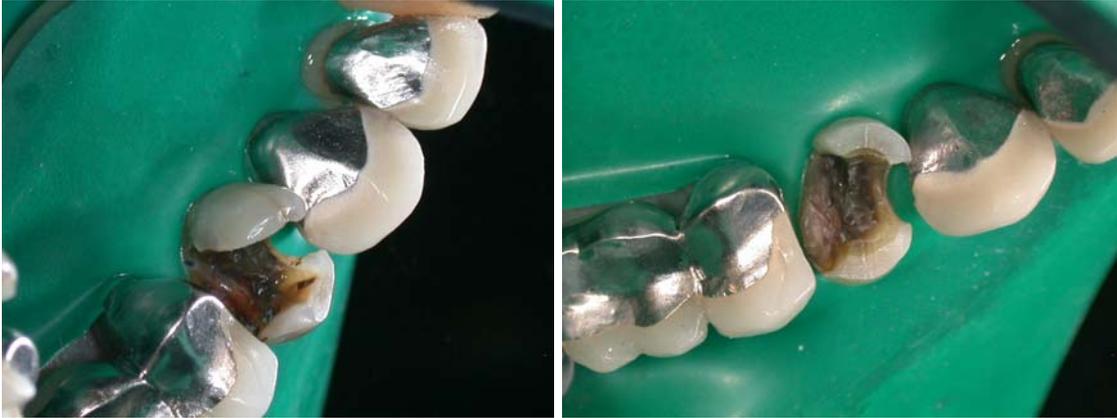
The last photo above shows the tooth after the rubber dam has been applied. Next, the silver filling is removed. Note the dark areas of decay; this shows one of the limitations of X-rays, decay has to be pretty advanced before it shows up. The second photo below shows the tooth after the decay has been removed.

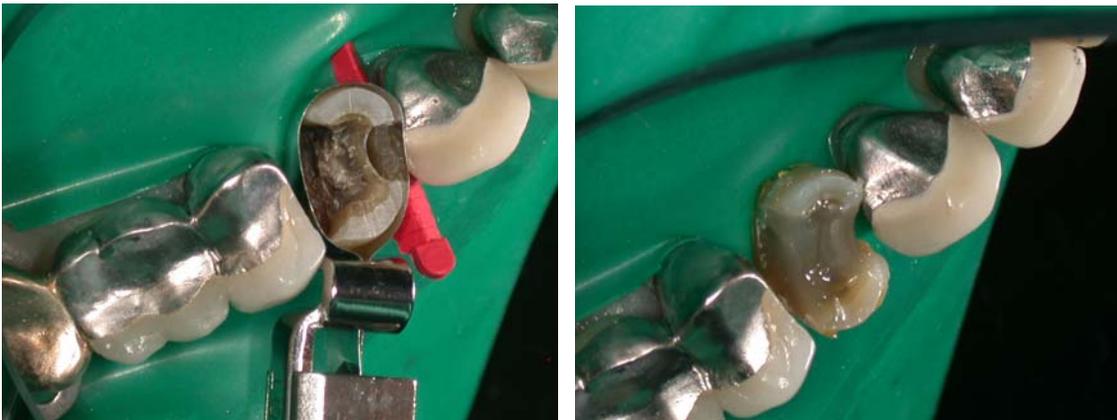
Next, a band is placed around the tooth and wedged into position (so that the buildup material won't ooze all over the place). The tooth is prepared with bonding agents, and a composite buildup is placed. The second photo (below right) shows the completed buildup ready for the preparation for the crown.

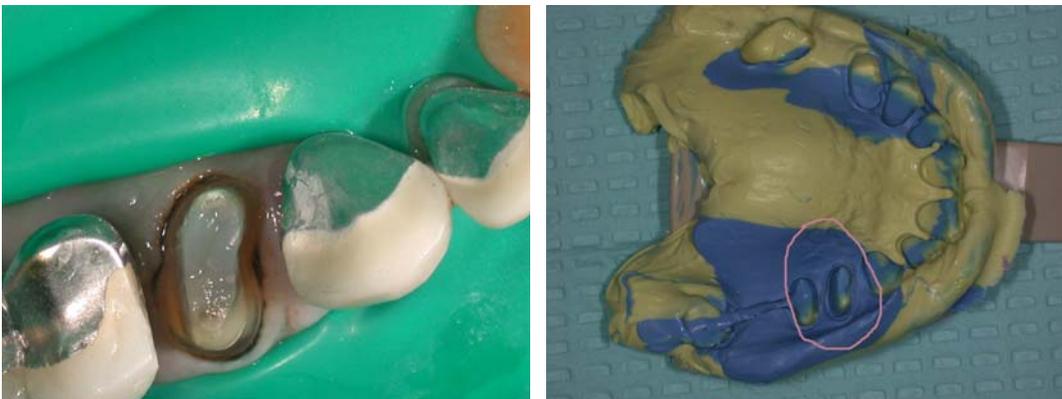
The two photos below show the tooth after the crown preparation is complete, and the impression with a circle drawn around the prepared tooth area. A thin "retraction cord" is visible in the left picture; this helps us get an impression below the gums.

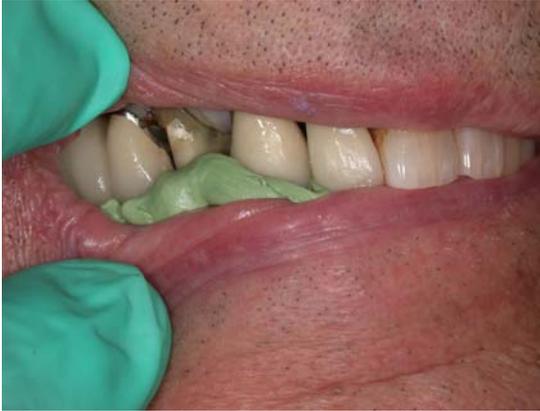
An impression of the lower teeth is taken (not shown) then a “bite registration” is taken to relate the upper impression to the lower teeth. The crown must match the bite, thus even though we’re working on an upper teeth we need models of both arches. This is sometimes confusing if you come in for a crown on a broken upper tooth and the first thing the assistant does is take impressions of the lower teeth!

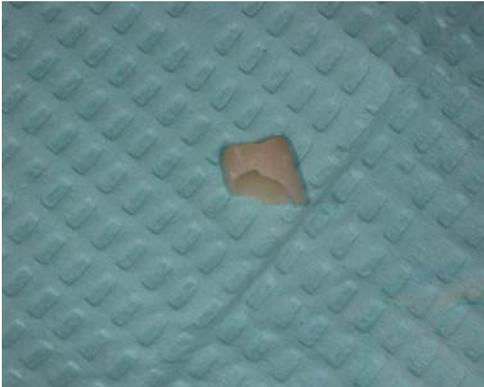
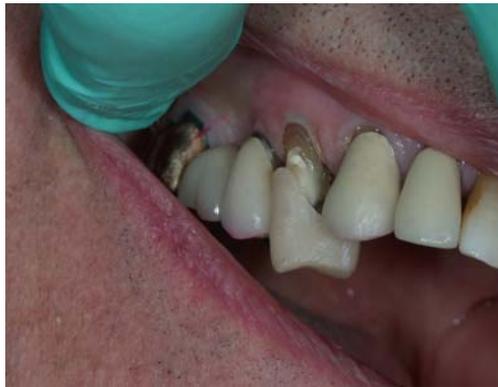
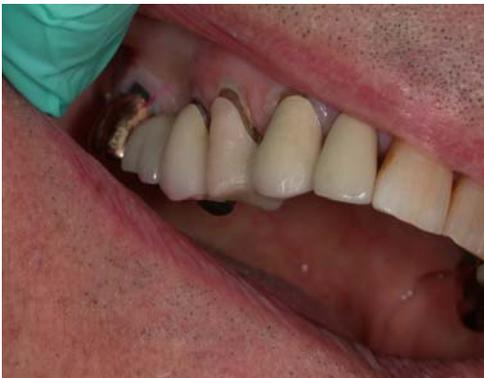
Finally, a temporary crown is made, usually of plastic; it fits over the tooth as shown in the last two pictures. I forgot to take a photo of the crown cemented on with temporary cement, but that’s one of the final steps. Before you leave, the assistant will check the color of your teeth so the lab can match the crown to your smile.
